UNDERWATER BRIDGE INSPECTION REPORT

STRUCTURE NO. 6413

CSAH NO. 6

CALDWELL BROOK

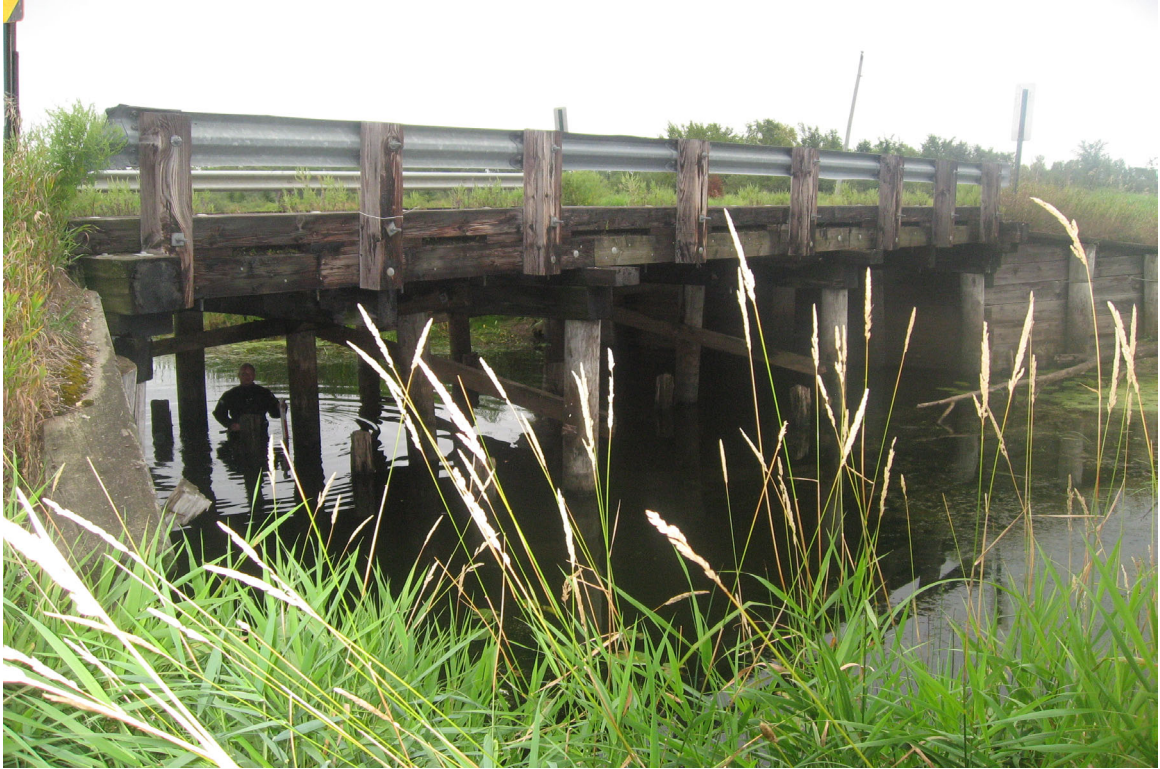
Photograph 1. Overall View of the Structure, Looking Southeast.

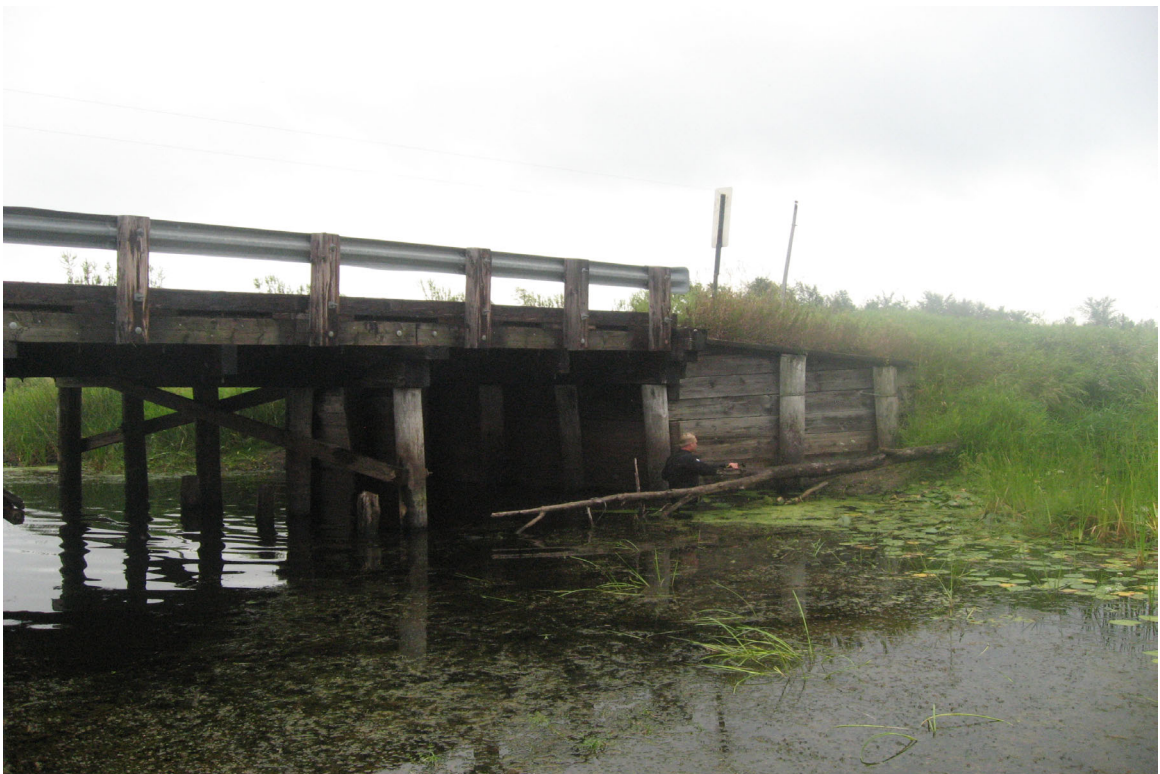
Photograph 2. View of the South Abutment and Bent 1, Looking Southeast.

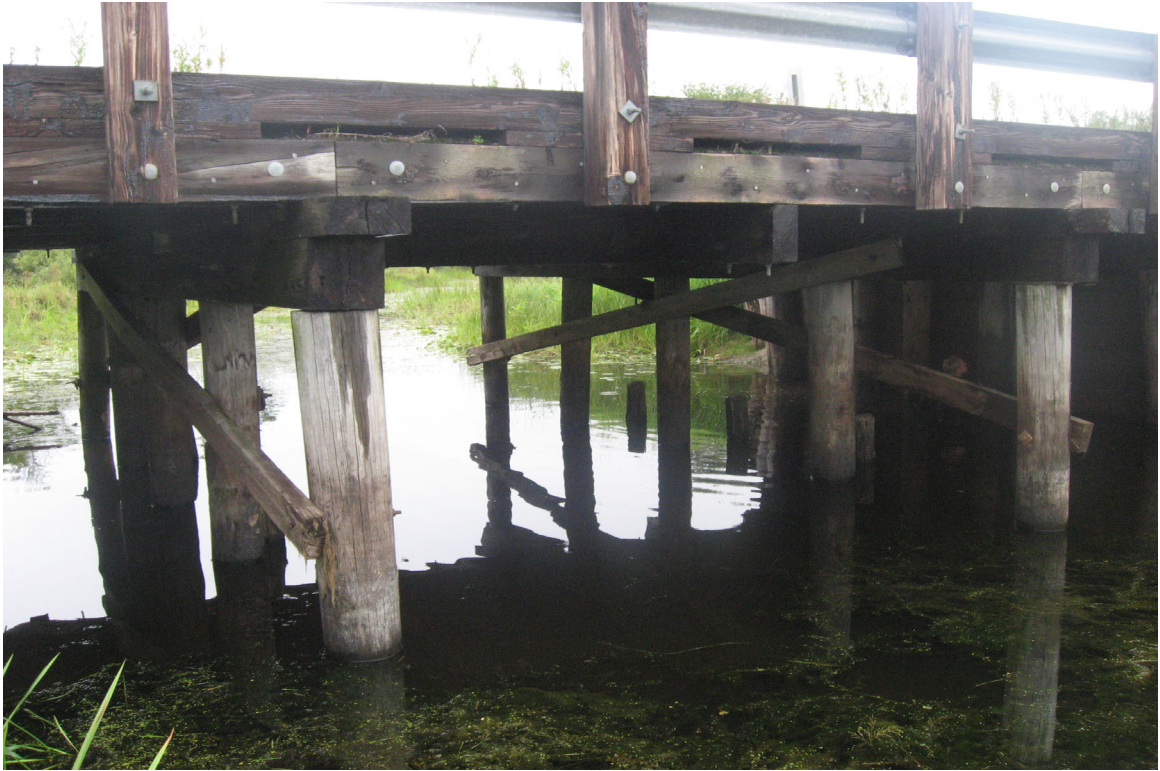
Photograph 3. View of Bents 1 and 2, Looking Northwest.

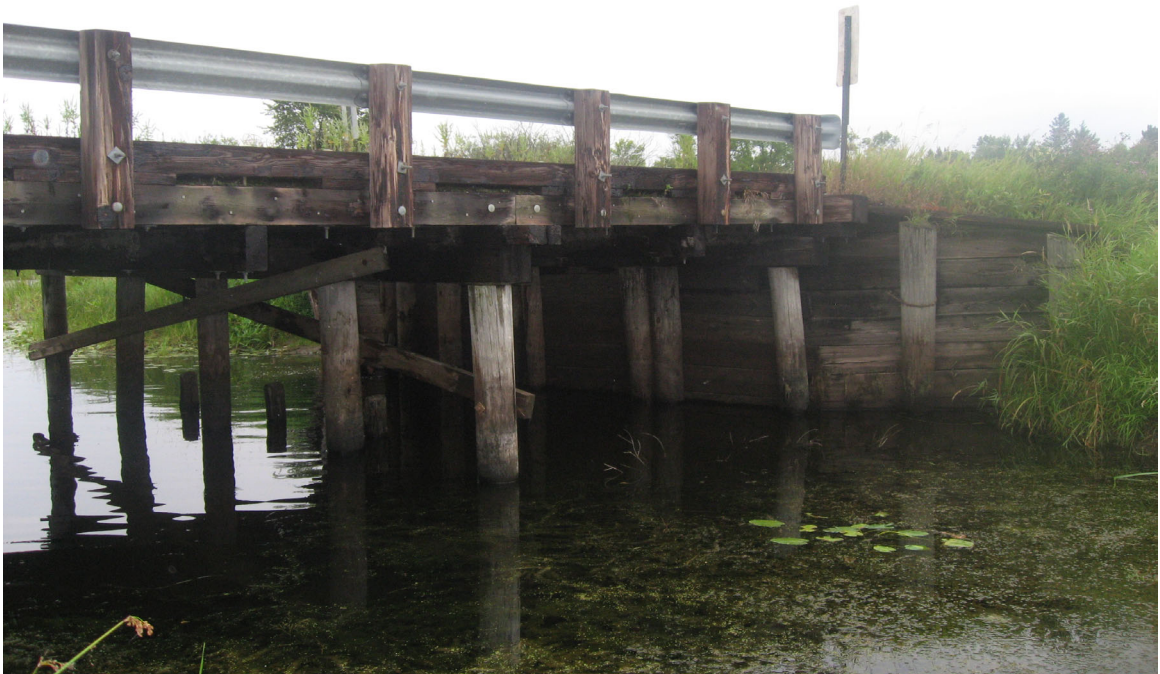
Photograph 4. View of North Abutment and Bent 2, Looking Northwest.

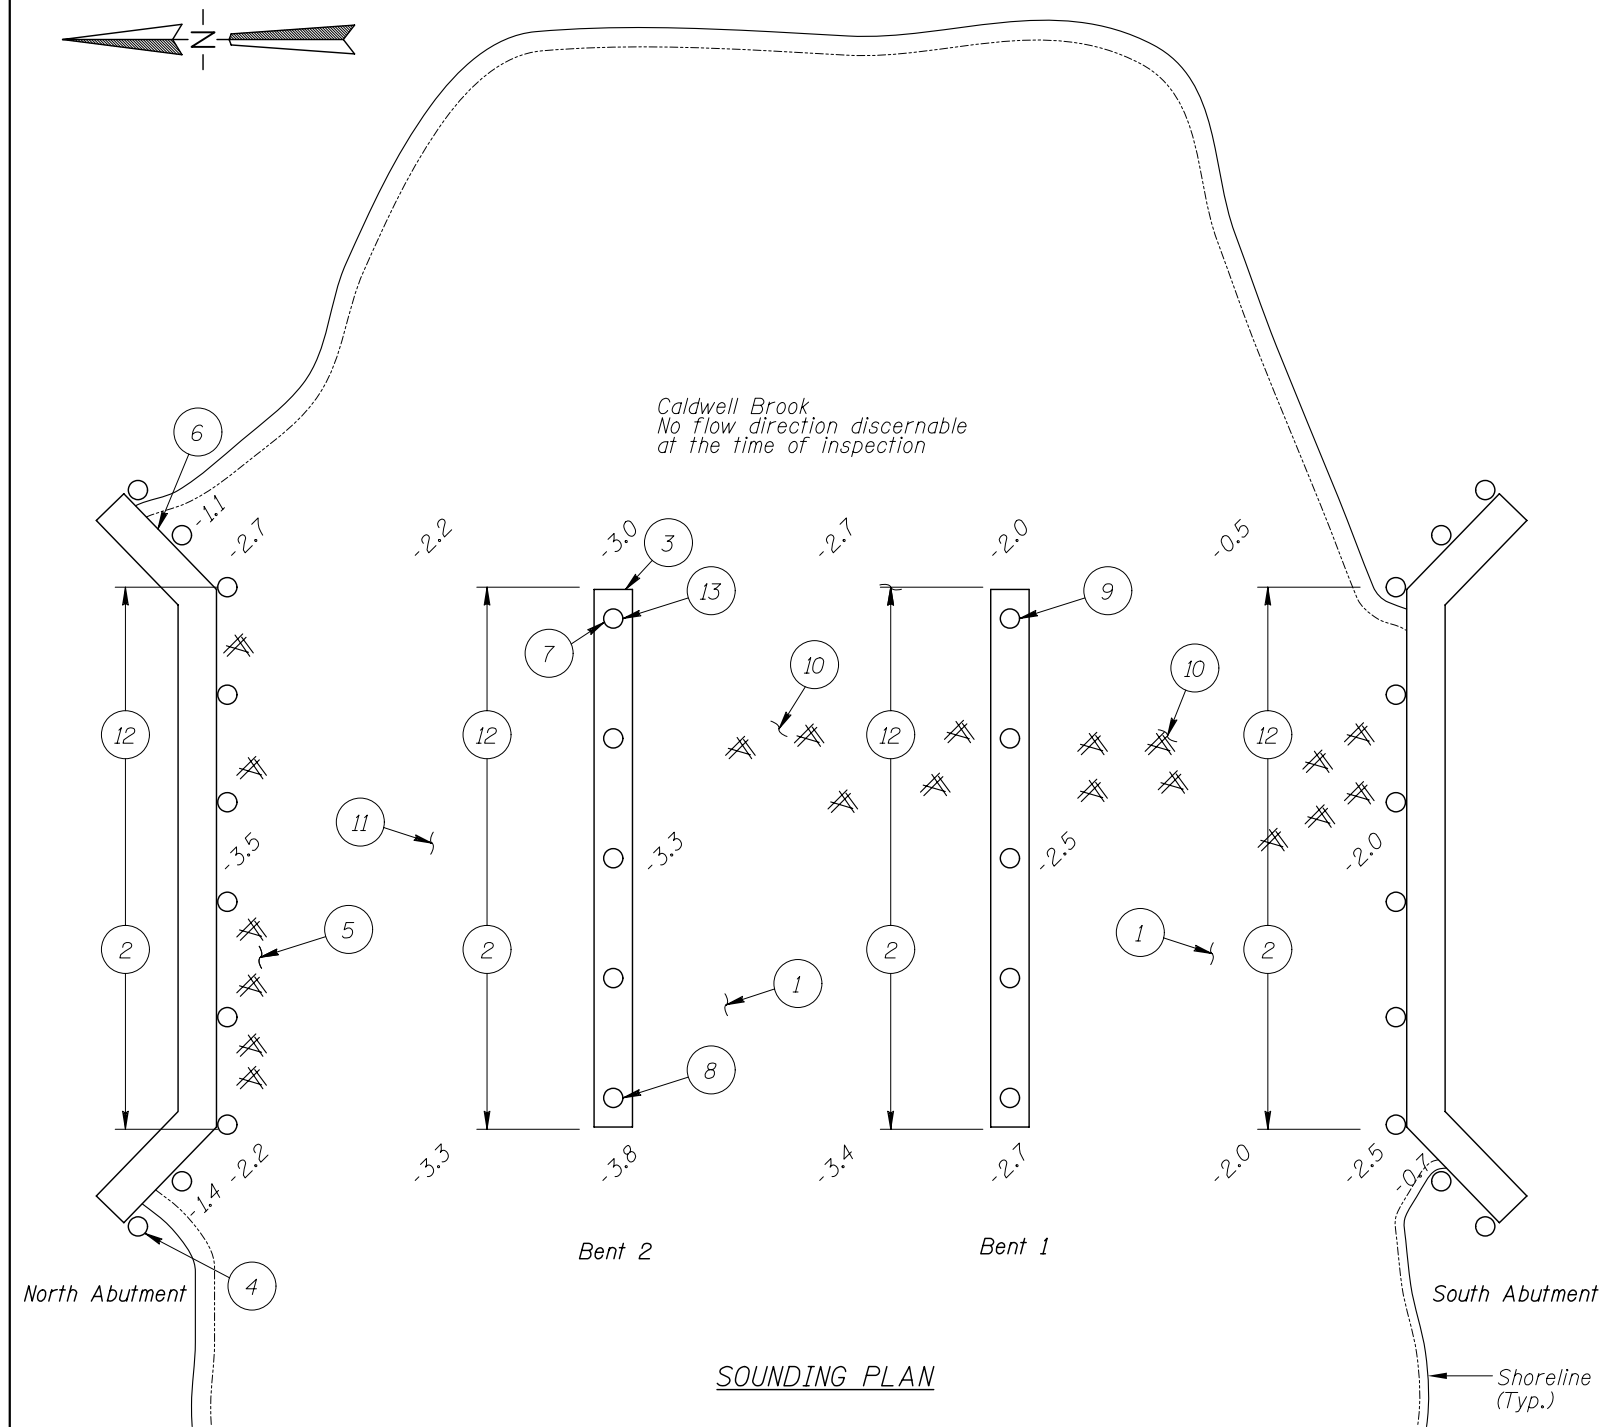
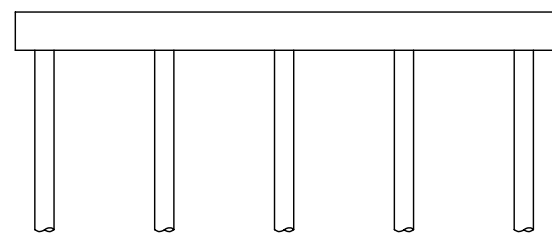
INSPECTION AND SOUNDING PLAN

1. The channel bottom material consisted of firm silty clay with less than 3 inches of probe rod penetration.
2. The timber piles typically exhibited moderate weathering with random checking up to 1/2 inch wide.

3. The timber pile cap exhibited a 1-inch-wide split along the eastern end of the bent.
4. Timber pile exhibited up to 100 percent loss of section in the top 2 feet of pile and delamination with up to 2 inches of awl penetration along the remaining portion of the pile, which has allowed up to 6 inches of wingwall displacement to the south.

5. A moderate accumulation of 2-inch-diameter and smaller timber debris was observed along the North Abutment.
6. The top of the northeast wingwall exhibited up to 4 inches of displacement to the south with no active loss of backfill noted.

7. The north brace exhibited a 5-foot-long split with a failed connection to the easternmost pile at Bent 2.
8. The south brace exhibited a 3-foot-long split with a failed connection to the westernmost pile at Bent 2.

9. The south brace exhibited a 5-foot-long split with a failed connection to the easternmost pile at Bent 1.
10. A light accumulation of 6-inch-diameter and smaller timber debris was observed on the channel bottom extending from the South Abutment to Bent 2.

11. Channel bottom consisted of soft silt with up to 6 inches of probe rod penetration.
12. The connection hardware typically exhibited corrosion with no appreciable loss of section noted.

13. The easternmost pile of Bent 2 was delaminated from the top of the pile down 3 feet with up to 3 inches of awl penetration.

Replace timber cross bracing members with splits and failed connections.
